IYC – St. Charles
September 14, 2009
John Howard Association of Illinois Site Visit

Summary

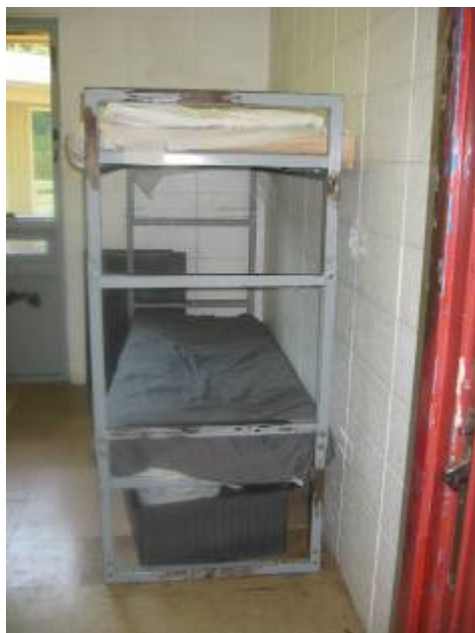
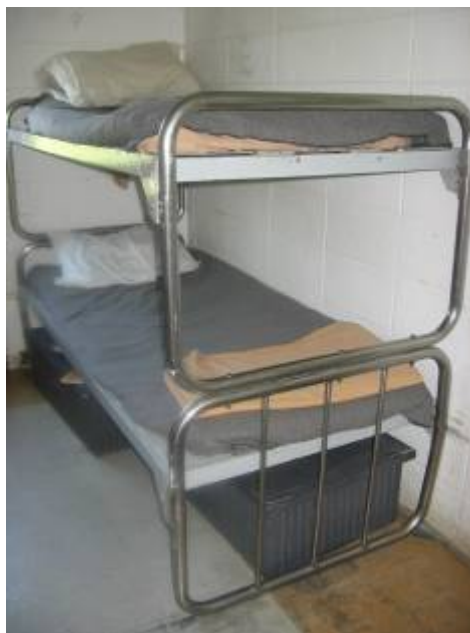
The vast majority of the rooms are configured to house two youth and those rooms almost always are equipped with bunk beds. These metal frame beds (typically bolted to the floor) provide the easiest, most apparent opportunity for suicide by providing a strong, stable base from which a piece of cloth or cord can be suspended. Even those rooms without bunk beds almost always have metal frame beds that are sufficiently high off the ground that they could be used as a hanging post.

Bunk Beds

- Eliminate the practice of double bunking and the use of bunk beds, and replace all beds with the type that is a solid piece with no legs or protrusions from which to tie off and bolt them to the floor. (Norix makes such a bed called the “Attenda floor mount bed.”)

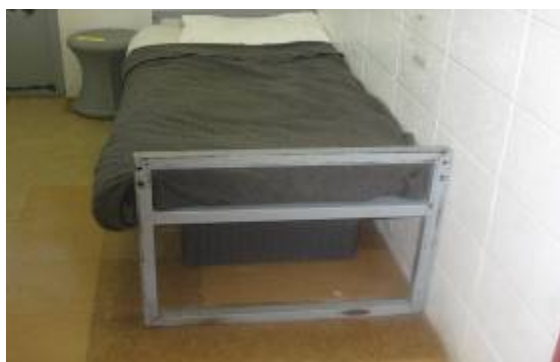
Single Bed

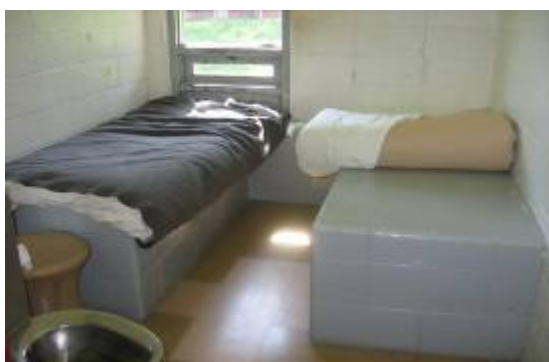
Safer "Slab Bed"

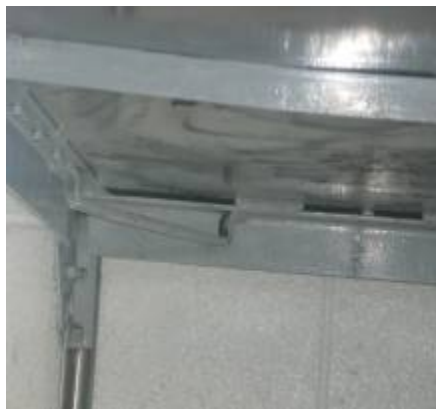
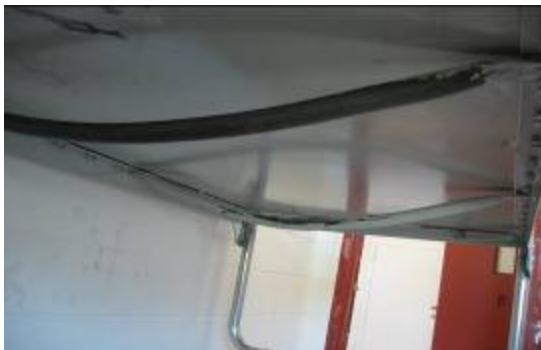
In addition, many beds have dangerous protrusions that offer additional opportunities for self harm.

Dangerous Protrusions

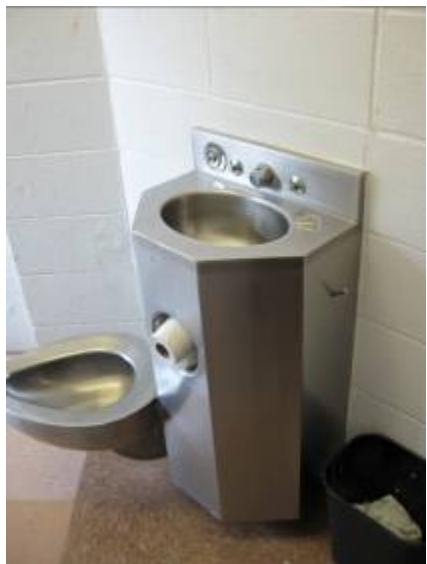
Metal Toilet/Sink Unit

- Replace the porcelain sinks and toilets with the steel toilet/sink units.
- Replace the vent covers with a break away plastic cover or insure that there are no items in the sleeping rooms that youth can use to climb to reach the covers. (This would involve bolting beds and stools and discarding the property boxes.)

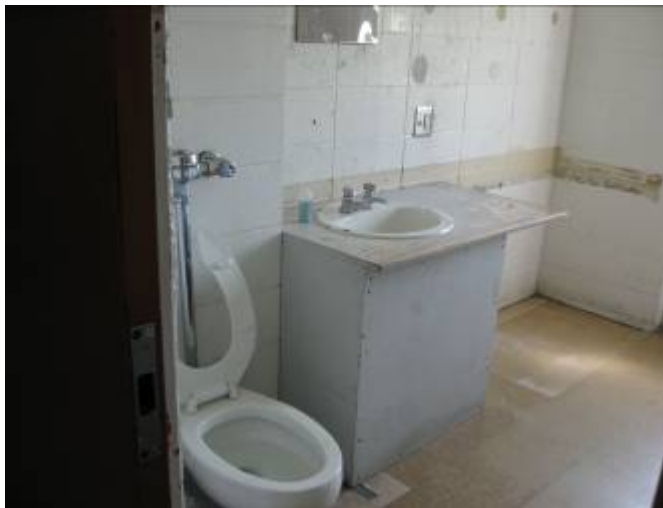
Less than half of the living units have sleeping rooms equipped with the more suicide proof metal toilet/sink units that have no exposed pipes or faucets. The other rooms have porcelain toilets and sinks with exposed pipes, and faucets from which a youth can tie off. Many even have removable toilet seats which pose an additional danger as a potential weapon. Most of the rooms with the porcelain toilets and sinks are constructed with a wooden partition that partially surrounds the sink and separates the toilet area from the sink. These partitions are old and many contain holes that present an additional location from which a youth can tie off.

Unsafe Porcelain Toilet and Sink

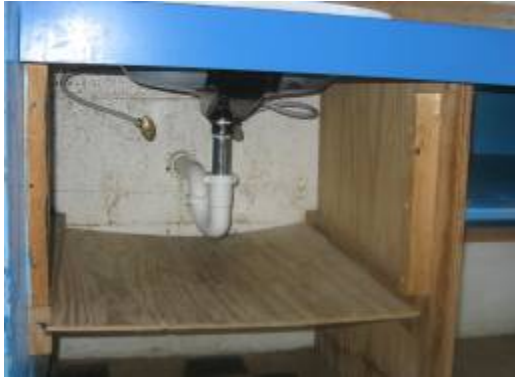
Exposed Unsafe Sink Pipes

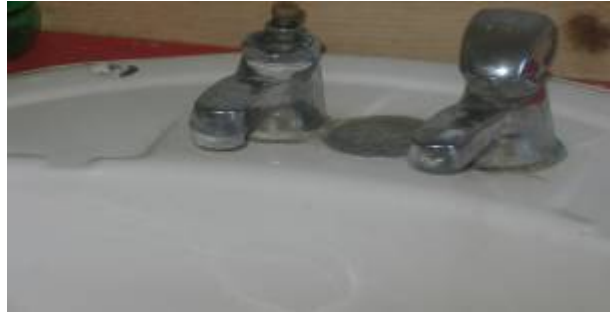
Unsafe Sink Faucets

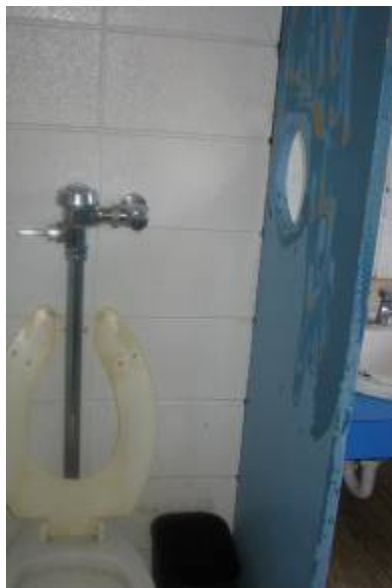
Porcelain Toilet with Partition

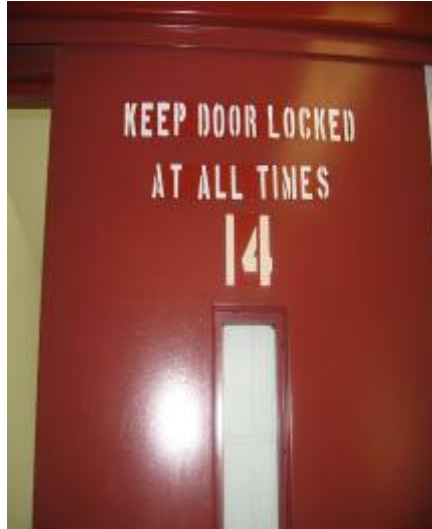
Entry to each sleeping room is through a heavy metal door kept closed and locked during much of the day. The view into the room is through a narrow glass window (approximately 4X15 inches) at eye level. Because of the placement of the window and the room's furnishings it is not possible to view residents who are inside without being immediately adjacent to the door.

Sleeping Room Door with Limited View

- Increase the ratio of staff to kids to 1 to 8 during the waking hours and 1 to 24 during the night. In lieu of increases in staff, and ideally as an additional safe-guard, install two way auditory devices in all sleeping rooms and cameras in some.

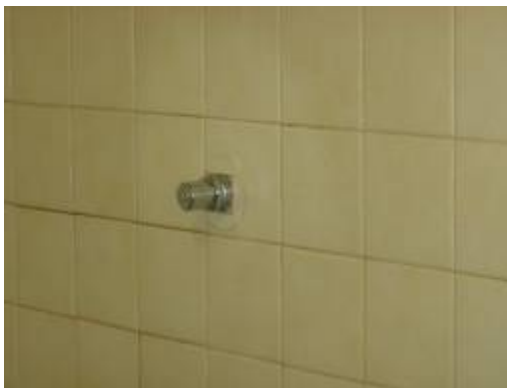
Each wing of a cottage has a communal shower room. These rooms have minimal furnishings: a few shower heads, perhaps a soap dish and a few hooks from which to hang a towel. State of the art correctional design and architecture has produced items which will serve these purposes without providing an opportunity for self-harm. Shower heads can be constructed of a short sloped piece of metal and hooks can be used which will break off or collapse if significant weight is exerted on them. Soap dishes can be recessed. In most instances the shower rooms at St. Charles have not employed these devices, or in the case of the hooks, the devices are old and seem to have solidified in place and can now support significant weight.

Unsafe Shower Control

- Replace all shower heads, soap dishes and hooks in the shower rooms which pose a risk for self-harm.
- Repair all broken and leaking plumbing in the sleeping rooms and shower rooms. Remove mildew and mold as needed.

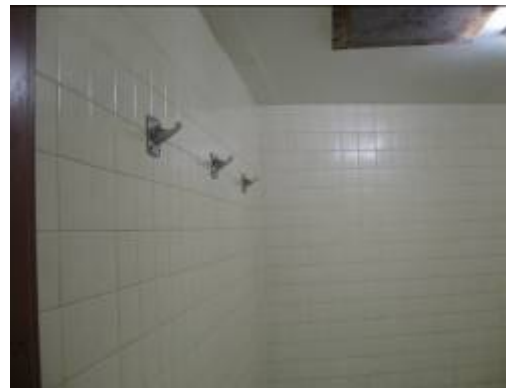
Unsafe Rigid Shower Hooks

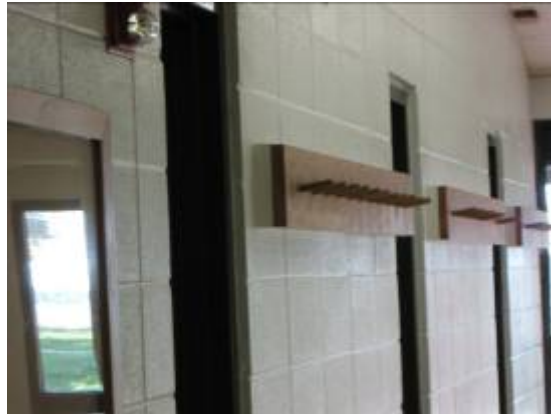
In general, common areas (day rooms and corridors) are themselves free of significant opportunities for self-harm particularly when coupled with more observation of staff. But even here there can be problems such as hooks used for hanging outerwear particularly with poor sight lines, the existence of partitions to separate areas and staff that spend time in enclosed offices.

Unsafe Coat Hooks in Dayroom

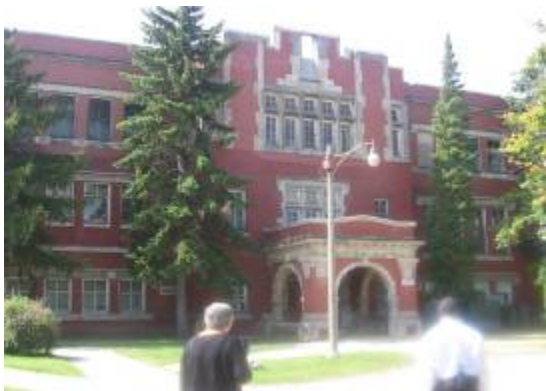
These problems did not occur overnight and are a result of trying to maintain an aging facility with decades of deferred maintenance and quick/cheap fixes to serious problems. One obvious example is the academic building/chapel that is now abandoned due to water damage, mold and mildew. The unfortunate consequence is that youth can no longer worship in the handsome sanctuary which boasts an original mural by world renowned Chicago artist Warner Sallman on the wall behind the altar.

Exterior of Academic Building/Chapel

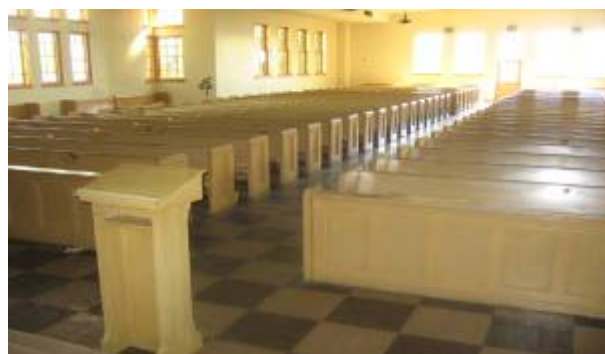
Interior of Sanctuary

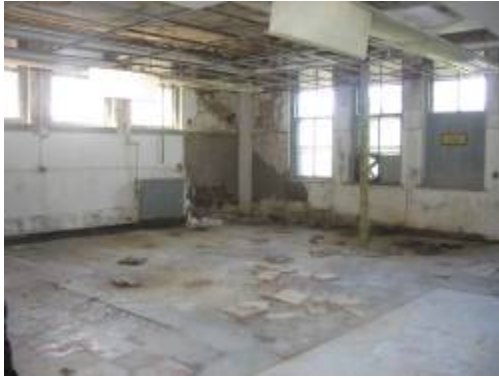
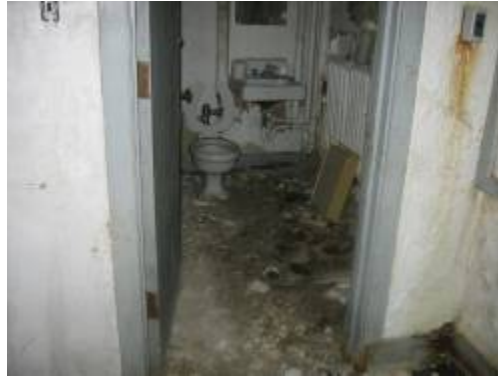
First Floor of the Academic Building Formerly the Wood Shop

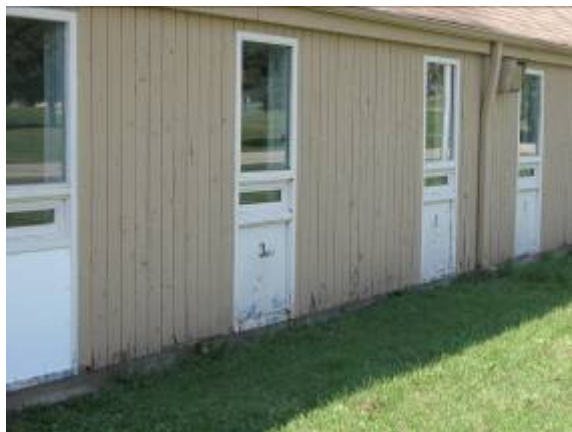
The ten housing units resemble one another in both appearance and construction. They are one story structures constructed economically in the seventies using cinder block coated with wood planking on the exterior set on concrete slabs; unbreakable glass windows which cannot be opened are set in metal frames. Floors in the building are covered with tile. Over the years the tiles have worn and many are cracked or missing. Because the mastic used to affix the tiles to the floor contained asbestos the cost of properly remediating the asbestos and replacing the tiles is high and many floors have not been fixed. The buildings have the original individual heating and air conditioning units; they are energy inefficient and have frequent breakdowns. The downspouts of these buildings were at one time connected to an underground drainage system but have since been disconnected. The result is water damage to some of the cottages which degrades the wood paneling/paint and some pooling of water and creation of muddy areas outside others.

Exterior of Williams Cottage

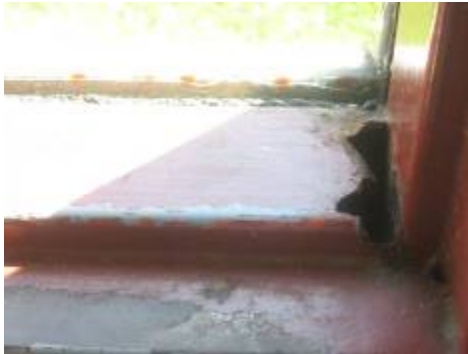
Most roofs on these buildings show their age with loose shingles and some bowing on a few. Window frames in the housing units are likewise degraded with many showing rusting and pitting.

Metal Window Frame

- Repair holes in walls, floors, and window sills.

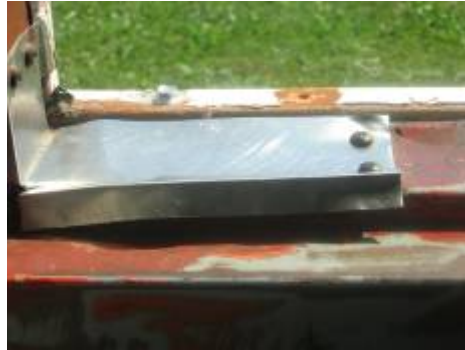
“Repaired” Metal Window Frame

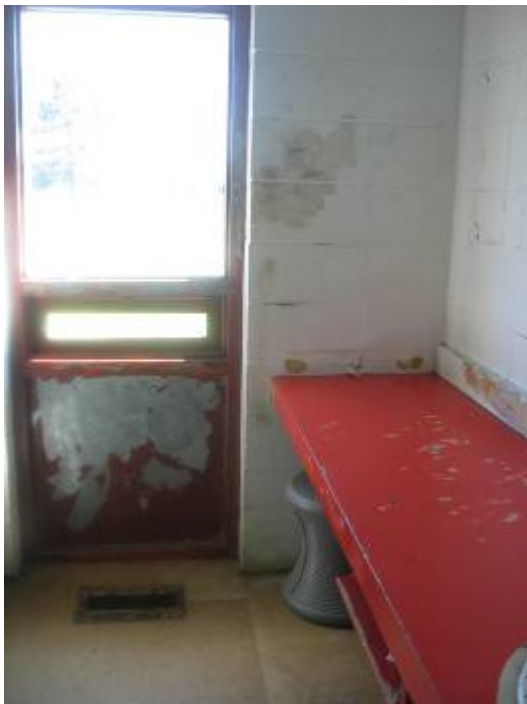
The combination of moisture and inconsistent heating and cooling has caused the deterioration of the material directly below many of the windows. In some rooms metal plates have been used to fill the spaces. Last December two youth escaped through such a space where they had loosened the screws holding the plate.

Sleeping Room with Metal Plate

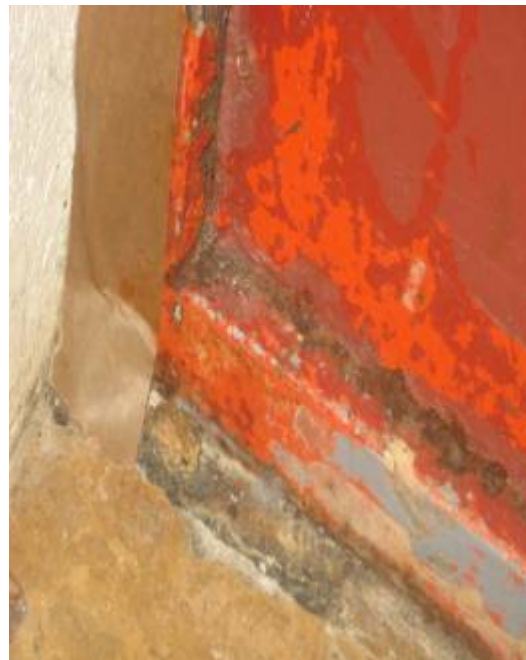
Close-up of Metal Plate
